DESTRUCTIVE TESTING OF TWENTY-YEAR-OLD PRESTRESSED CONCRETE BRIDGE BEAMS IN FREEZING-THAWING REGION

*LIU Jin-liang, JIA Yan-min**

*Northeast Forestry University, School of Civil Engineering, Harbin, 150040, China;
jinliangliu_2015@126.com; yanminjia2008@126.com*

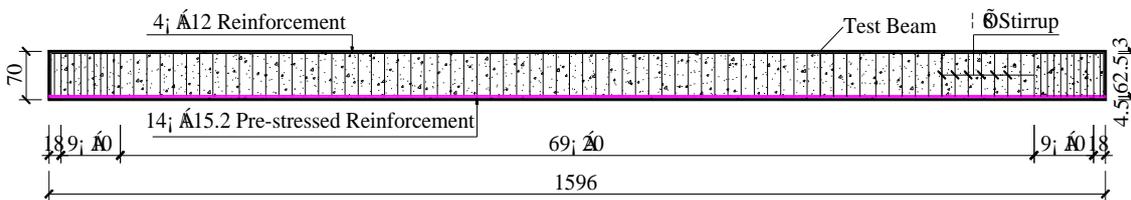
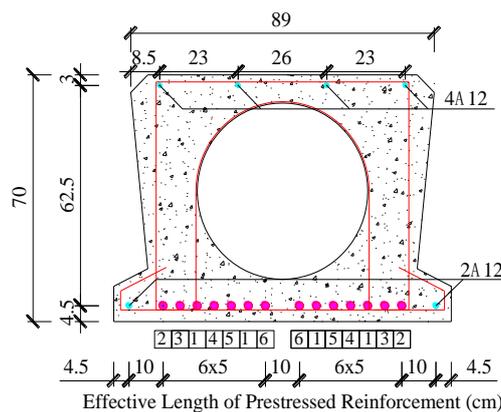
Fig. 1 - Dimensions and reinforcement of tested beams (Unit: cm)

The bridge where the test beams are located was built in 1995, and it lies within Shenyang-Siping Section of G1 Expressway of China, it is a freezing-thawing region in Northeast China. The highest temperature reached 35°C in summer, and the lowest temperature in winter reached -25°C, the annual highest temperature difference reached 60°C [16]. The calculation span of the test beam is 15.6m, the oblique crossing angle is 90°, the width is 99cm and the height is 70cm. A circle with diameter of 50cm was cut out from the centre, the thickness of top plate is 8cm, the thickness of bottom plate is 12cm and hollow plate was cast by C40 concrete. The prestressed steel strands of the test beam applies ϕ_j 15.24 (7 ϕ 5) type, the standard strength is 1,860Mpa and the tensioning control stress is 1,395Mpa, the longitudinal non-prestressed reinforcement applies HRB335 type, with diameter of 12mm; the stirrup applies R235 reinforcement with diameter of 8mm; The following Figure 1 shows the structural drawing on the reinforcement and section of the test beam.

(a) vertical section

(b) cross section

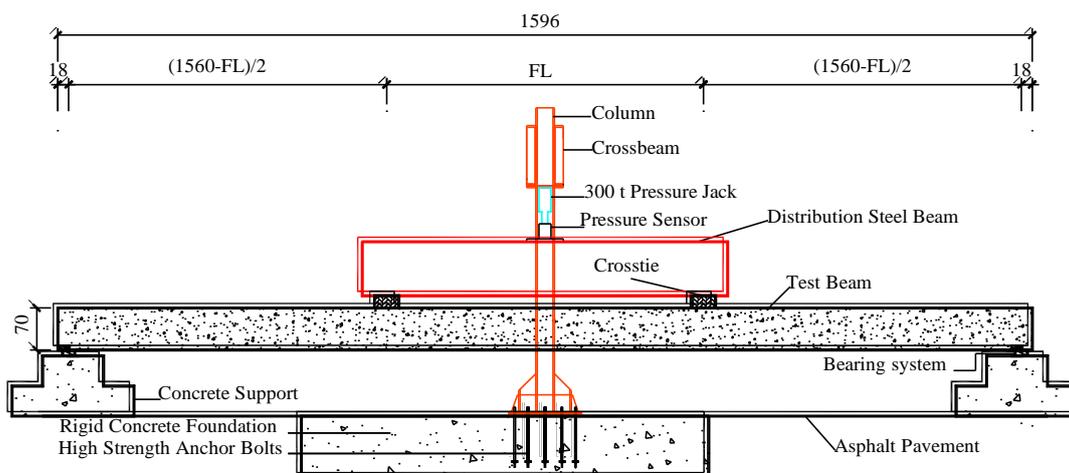
Fig. 2 - Details of loading test (Unit: cm)

To study the response of the tested beams under the bending load, the beams subjected to pure bending load segment at 2m scheme, i.e. FL=2.0m, the test beams were named as M2-1 and M2-2, respectively. In order to obtain the response of the test beam under the uniform load, the paper carried out the classical Trisection Point Loading Test for structure [19], i.e. FL=5.2m, the test beams were named as M5.2-1 and M5.2-2, respectively. The following Figure 2 shows the details of loading test.

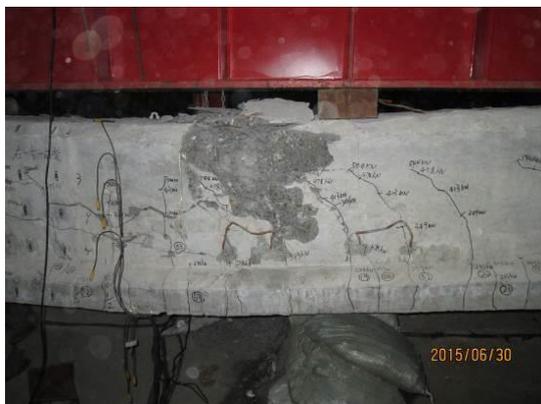
Fig. 3(a) - Failure state of beam M2-1

The destruction process of the test beam M2-1 and M2-2 are similar and divided into three stages: stage 1: reversed deflection had existed in the beam before cracks appeared. Following the increase of load, the reversed deflection decreased and disappeared, and the deflection kept linear growth, this phenomenon shows that the structure lay in the stage of elastic operation. Stage 2: the test beams cracked to the yielding stage of common reinforcement. When the test beam M2-1 and M2-2 continued to be loaded until approximate 221kN and 240kN, the concrete at the bottom edge of the pure bending segment firstly cracked vertically, thereafter, the quantity of such vertical crack increased continually and the cracks grew, the vertical crack appearing during the early period unceasingly expanded and extended upwardly, and U-shape crack formed at last. When the test beam M2-1 and M2-2 were loaded to 351kN and 362kN, oblique crack started to appear in the web between the loading point of the shearing-bending segment and bearing, in addition, the crack extended obliquely toward the direction of the loading point from the edge at beam bottom. At the same time, the vertical crack in the purely bending segment continued to extend upwardly. The extension of oblique crack in the shearing-bending segment gradually quickened after the growth of vertical crack in the purely bending segment gradually reached stable state. The lateral crack in the bottom plate connected together and formed U-shape crack at last. Stage 3: common reinforcement yielded to structure destruction stage. When the test beam M2-1 and M2-2 were loaded to 416.5kN and 447.6kN, the common reinforcement in the tensioning zone yielded and failed. When load was exerted continually, the midspan deflection of the test beam became large quickly, the crack became wide quickly. Finally, the concrete in the compressive zone of the purely-bending segment was crushed (as shown in Figure 3(a) and Figure 3(b)). The ultimate load corresponding to the failure of M2-1 and M2-2 are respectively 564kN and 572kN. After the test beam failed, the concrete in the bottom plate of the purely-bending segment was chiselled away, the status of pre-stressed reinforcement was observed, it was found that the pre-stressed reinforcement was not broken. As described above, the test beam M2-1 and M2-2 are typical anti-bending destruction of normal section, which belongs to plastic failure.

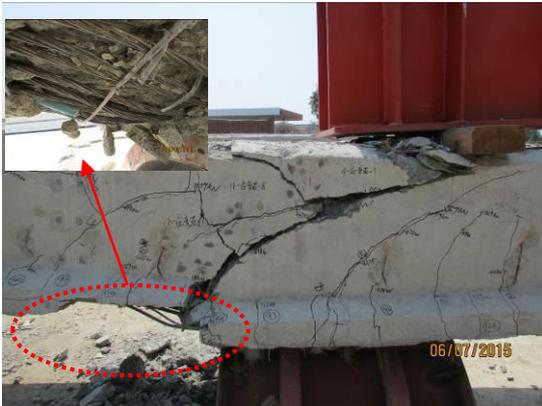
Fig. 4(a) - Failure state of beam M5.2-1

The destruction process of the test beam M5.2-1 and M5.2-2 are similar and divided into three stages: The first stage is the same as the stage 1 of the destruction process of the test beam M2-1 and M2-2. Stage 2: the test beams cracked to the yielding stage of common reinforcement. When the test beam M5.2-1 and M5.2-2 continued to be loaded until approximate 315kN and 298kN, the concrete at the bottom edge of the purely bending segment firstly cracked vertically, thereafter, the quantity of such vertical crack increased continually and the cracks grew, the

vertical crack appearing at the early period unceasingly expanded and extended upwardly. And U-shape crack formed at last of this stage. Oblique crack started to appear in the web between the loading point of the shearing-bending segment and bearing when the test beam M5.2-1 and M5.2-2 were loaded to 365kN and 321kN. In addition, the crack extended obliquely toward the direction of the loading point from the edge at beam bottom, following the continual increase of load, the extension of oblique crack in the shearing-bending segment gradually quickened, until the oblique crack and the lateral crack in the bottom plate connected together and formed U-shape crack. At the same time, the vertical crack in the purely bending segment continued to extend upwardly and slowly. Stage 3: common reinforcement yielded to structure destruction stage. When the test beam M5.2-1 and M5.2-2 were loaded to 518.3kN and 545.1kN, the common reinforcement in the tensioning zone yielded and failed. After this load, the width and height of vertical crack in the zone of bending moment failed to grow continually. However, the width of oblique crack in the bending-shearing zone of the test beam quickly increased. Moreover, it was found that pre-stressed reinforcement at the end of the test beam apparently slipped, and the concrete in the bottom plate of the test beam crushed and fell off, simultaneously, the deflection and concrete strain near to the loading point on this side quickly increased. Finally, shearing-compression failure appeared on the slippage side of the pre-stressed reinforcement of the test beam (as presented in Figure 4(a) and Figure 4(b)). The ultimate load corresponding to the failure of M5.2-1 and M5.2-2 are respectively 565.7kN and 565.9kN. After the test beam failed, the concrete in the bottom plate of the shearing-bending segment was chiselled away, it was found that the pre-stressed reinforcement apparently slipped inside concrete, which was a bond failure. After serving in freeze-thaw area for 20 years, the corrosion of pre-stressed reinforcement and the freeze-thaw damage of concrete led to insufficient bonding force, but the anchorage of prestressing reinforcement insufficient at the design stage. As described above, the test beam M5.2-1 and M5.2-2 are atypical shearing-compression destruction caused by the slippage of pre-stressed reinforcement, which belongs to brittle failure.

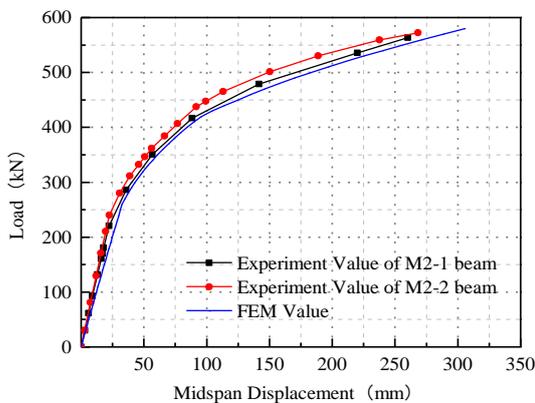
(a) M2-1 and M2-2

It can be known by comparing the displacement at the midspan section and the quartile section, the change trends of all sections are basically similar. With the deflection at the midspan section as an example, the paper introduced the deflection change in the destruction process of the test beam. The following Figure 5(a) shows the load-deflection curves of the test beam M2-1, M2-2 and the finite element model (FEM), Figure 5(b) shows the load-deflection curves of the test beam M5.2-1, M5.2-2 and the finite element model.

Fig. 5 - Load- displacement curves of midspan section of beam

It can be known from Figure 5(a) that the midspan displacements were 22.25mm and 22.57mm after the crack appeared, respectively, which are basically similar as the reversed deflection values of the test beams. As for M2-1 and M2-2 beam, the midspan deflections of the test beams were 88.43mm and 99.25mm after common reinforcement yielded, respectively, which were approximately $1/166L$. The midspan deflections were 260.15mm and 268.43mm at the ultimate loads, respectively, which were approximately $1/59L$. The maximum deflection obtained from the finite element model is similar as the test result of the test beam, the maximum value was 306mm. As described above, it is shown that the test beam still has excellent ductility after having served in the freezing-thawing zone for 20 years, apparent ductility anti-bending destruction features were displayed.

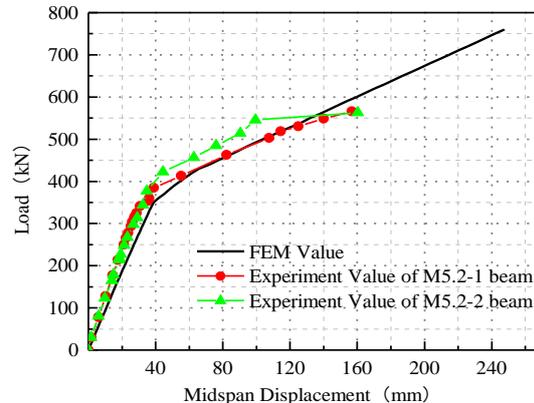
(b) M5.2-1 and M5.2-2

It can be known from Figure 5(b) that the midspan displacements were respectively 27.36mm and 26.83mm after M5.2-1 and M5.2-2 beam cracked, respectively, which are basically similar as the reversed deflection values of the test beams. As for M5.2-1 and M5.2-2 beam, the midspan

deflections of the test beams were 107.61mm and 99.48mm at the point of common reinforcement yielded, respectively, which were approximately 1/150L. The pre-stressed reinforcement in the bending-shearing zone slipped after reinforcement yielded, brittle destruction quickly occurred in two pieces of test beam. At the ultimate loads, the midspan deflections were 156.83mm and 160.23mm, respectively, which were approximately 1/98L. According to the calculation result in the finite element method, when the test beam was destructed, the maximum deflection value occurred in the midspan, the calculation value was 247mm. When the test beam was destructed, the maximum displacements occurred near to 5/8L, which were 166.70mm and 166.92mm, respectively. As described above, the reinforcement of the test beam had excellent ductility before common reinforcement yielded. When the pre-stressed reinforcement of the test beam slipped, not only was the structural bearing capacity lowered, but also the destruction location of structure was changed.

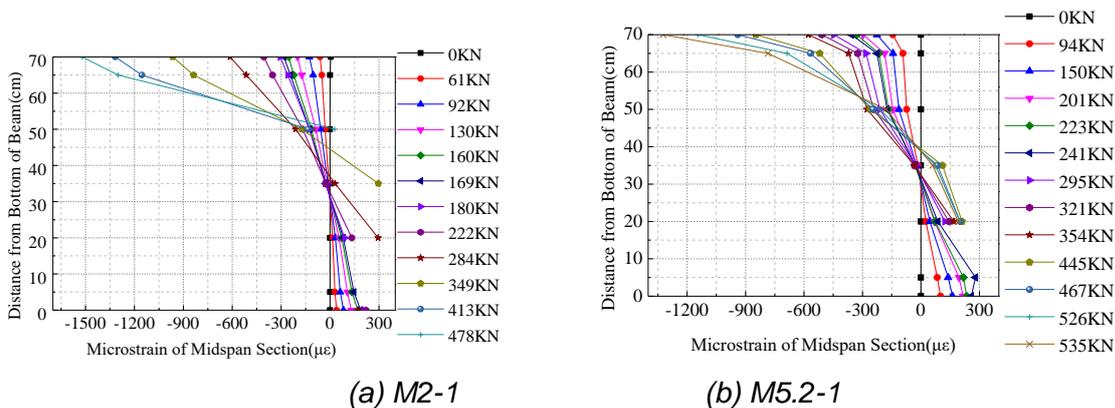
Fig. 6 - Variation of strain along cross section of beam

The following Figure 6(a) shows the distribution of concrete strain along beam height in the midspan section of the test beam M2-1, the following Figure 6(b) shows the distribution of concrete strain along beam height at the midspan section of the test beam M5.2-1. According to Figure 6(a) and Figure 6(b), before the structure cracked, the section of the test beam M2-1 and M5.2-1 basically conformed to the hypothesis on plane section under the action of various levels of load, the ratio between the section height of the relative compressive zone and the effective height, i.e. x/h_0 is about 0.48. After the structure cracked, the neutral axis gradually moved upwardly following the increase of load. When the test beam M2-1 was destructed, the concrete at the compressive zone was crushed, x/h_0 reduced to 0.30. The neutral axis of the midspan section moved upwardly and the speed was slowly than that of M2-1 after the test beam M5.2-1 cracked. When the test beam would be destructed, the neutral axis of the midspan section would not move upwardly again, and x/h_0 reduced to 0.37 at last.

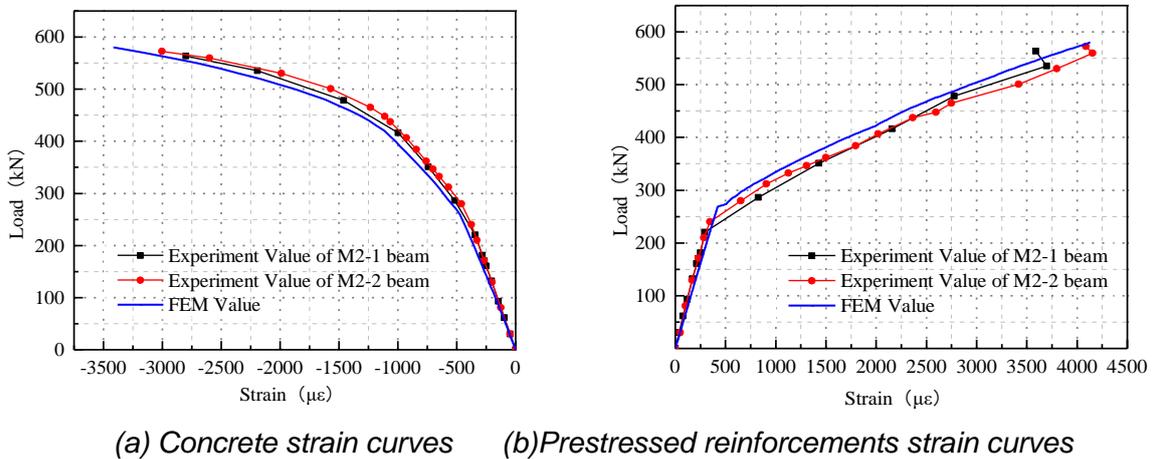
Fig. 7 - Load- strain curves of beam M2-1 and M2-2

The following Figure 7(a) and Figure 7(b) show the curve that the concrete strain at the top edge and strain of pre-stressed reinforcement at the midspan section for the test beam M2-1 and M2-2 changes following load. It can be known that, the strain of concrete and pre-stressed reinforcement in the section linearly increased following load before the test beam cracked. When the load arrive between the cracking load and the yielding load of reinforcement, the linear increase of the strain of concrete and pre-stressed reinforcement in the section were destroyed, the increase speed of strain is higher than linear increase. After reinforcement yielded, the strain of concrete and pre-stressed reinforcement in the section quickly increased following the increase of

load. Finally, the concrete strain at the top edge of section reached the compressive ultimate strain of concrete, which lead the concrete at the top edge of section was crushed and the test beam failed.

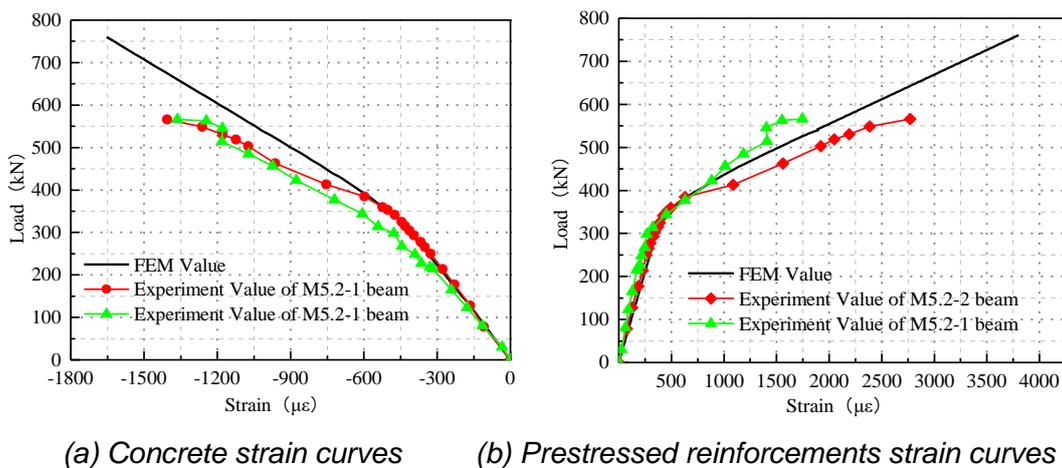
Fig. 8 - Load- strain curves of beam M5.2-1 and M5.2-2

The following Figure 8(a) and Figure 8(b) show the curve that the concrete strain at the top edge and strain of pre-stressed reinforcement the midspan section for the test beam M5.2-1 and M5.2-2 changes following load. It can be known that, the strain of concrete and pre-stressed reinforcement in the section linearly increased following load before the test beam cracked. When the load arrive between the cracking load and the yielding load of reinforcement, the linear increase of the strain of concrete and pre-stressed reinforcement in the section were destroyed, the increase speed of strain was higher than linear increase. After reinforcement yielded, the strain of concrete and pre-stressed reinforcement in the section quickly increased following the increase of load, but the increase speed was apparently lower than the finite element calculation value. Following the continual increase of load, the pre-stressed reinforcement in the structure slipped and the structure failed ahead of time. The concrete strain at the top edge of the midspan section do not reach the compressive ultimate strain, and concrete was not crushed.
