CONTRIBUTION TO THE POTENTIAL OF USING FRP MATERIALS IN THE REHABILITATION AND STABILIZATION OF TIMBERED BUILDINGS

Tomáš Čejka¹, Radek Zigler², Klára Kroftová³ and Markéta Šmidtová⁴

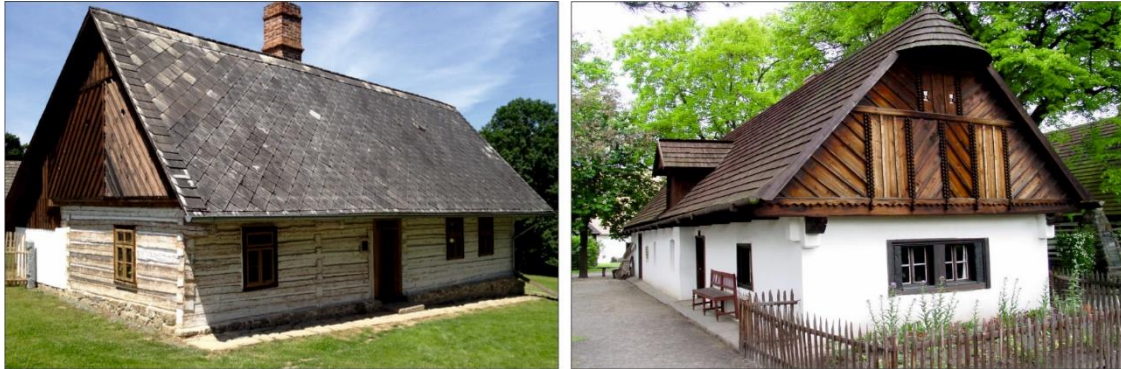
Fig. 1: Examples of timbered houses a) Příbram; b) Přerov nad Labem

The timbered constructions (Fig. 1), whose origins may be traced to mainly Central and Eastern Europe, were a widespread construction technology for residential and farm buildings used in our country from the Early Middle Ages. After the 12th century, timbered houses represented the predominant type of residential development on our territory, and their use in rural areas prevailed until the late 18th and the early 19th century, in northern and western Bohemia even until the late 19th century. The decline of building timbered constructions was primarily due to the prohibition of wooden constructions because of the risk and spread of fires in 1816. According to Schedel's World Chronicle from the end of the 15th century, timbered framing was also found in urban buildings. There are timbered houses with a timbered wall construction on the ground floor and their upper floor construction is supported on the so-called pedestal formed by protruding columns and beams (ground plates) and constructions with a single living space resting on a masonry, mostly stonework, construction.

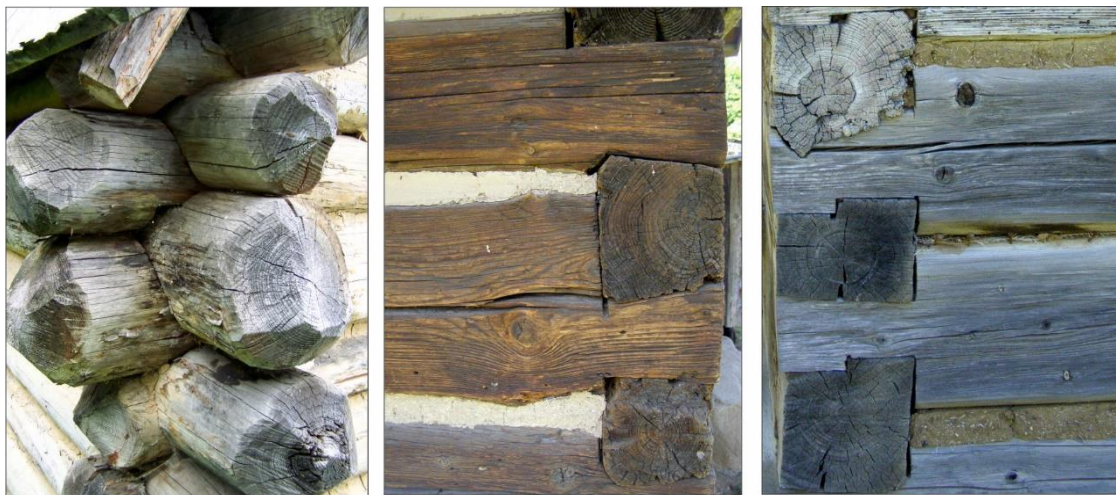
Fig. 2: Examples of carpentry corner joints of timbered houses

Timbered walls are usually made of horizontally mutually superposed solid logs or beams, most often joined in corners by the dovetail joint, or a dovetail joint with opposite inclined sides without overlaps to prevent the bond loosening and beam slippage; there may also be gaps between slabbed sections. From the late 18th century, the above bond was replaced by more demanding, so-called interlocks, with perpendicularly cut horizontal and vertical surfaces – mortises with perpendicular walls. Figs. 2a, 2b and 2c show examples of carpentry corner joints of timbered buildings. The gaps between horizontal wall elements were sealed with moss and subsequently puddled with clay, cob, reinforced with straw, animal hair, etc.

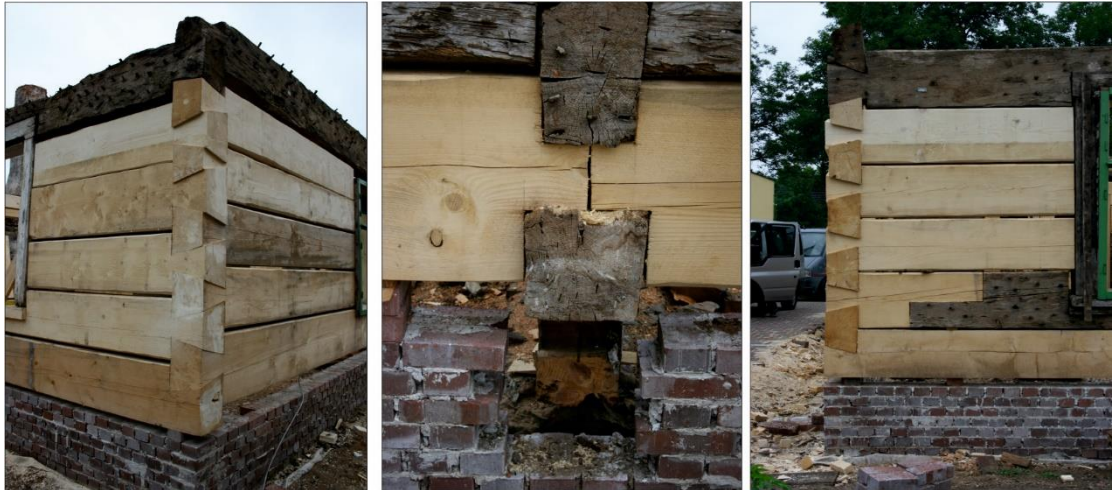
Fig. 4: Rehabilitation of elements and joints of timbered wall using the classic method – replacement, sealing

In the construction and technical perspective, the rehabilitation of damaged structural members and joints may be carried out as follows. Loosened connections must be wedged out or strengthened with suitably placed prostheses, stiffening elements, partial resin grouts, reinforcement (e.g. glass fibre connections, special steel bars), etc. (Fig. 4).

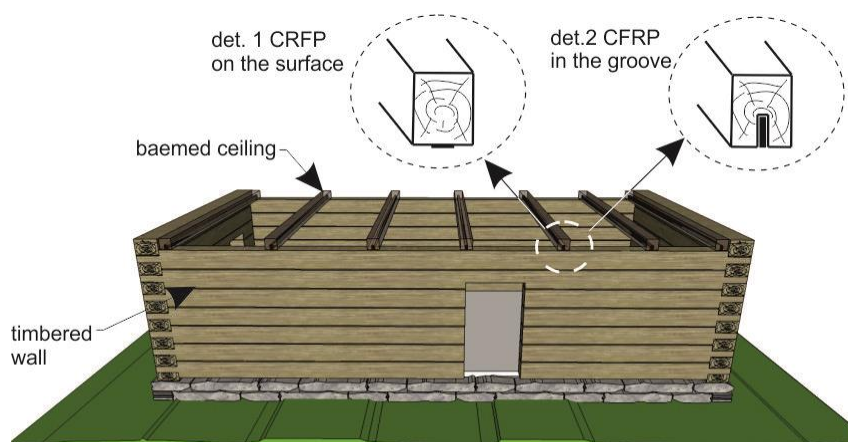
Fig. 5: Securing the spatial rigidity of a timbered construction in the case of degraded tie beams – reinforcing FRP strips or lamellae are led along the surface or in the groove of joists and anchored to the outside

surface of timbered walls

In the case of vertical structures, the use of prestressing or non-prestressed composite strips based on high-strength fibres and epoxy resin is preferred to capture the horizontal forces exerted by the roof truss to avoid the tilting of timbered walls - opening up of the building - and the slippage of the upper beams of the wall. It is advisable to place these strips on the surface of joists (Fig. 5) and anchor them to the outer wall surface. The composite strips placed in this way increase the rigidity of the building and may partly replace transverse (interior) timbered walls securing the spatial stability and rigidity of the construction.
